SERVICE BULLETIN

Classification:	Reference:	Date
BT02-017	NTB02-042	April 10, 2002

2002 ALTIMA; WATER LEAKS ON FRONT FLOOR AREA

APPLIED VEHICLE(S): 2002 Altima with Bose audio system.

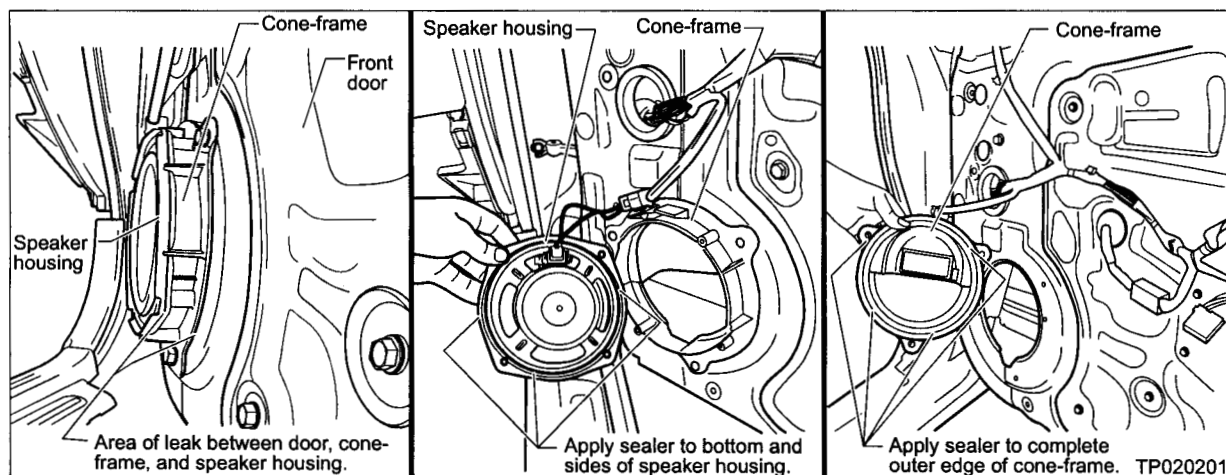
Figure 1

- A poor seal between the front door speaker housing and the speaker "cone-frame",
- Poor sealing between the speaker cone-frame and door inner panel, or
- The waist molding at the bottom of the front door window frame is out of place.

NOTE: See the Service Manual, page EI-10, for clip and fastener information.
 - b. Park the vehicle sideways on an incline so that the side with the wet floor is higher than the dry side (water inside the doorframe will run towards the inside of the vehicle).
 - c. Spray water on the top portion (window area) of the door, and the A pillar.
 - d. Observe the lower area of the speaker housing and speaker cone-frame. If water is leaking from this area it should be visible within 15 minutes (see figure1).

2. Separate the speaker housing from the cone-frame and the cone-frame from the door panel (see figure 1).
3. Apply sealer (Permatex Ultra Black 598B Hi-temp RTV silicone or equivalent) to the speaker housing bottom and sides, and to the entire outer edge of the cone-frame (see figure 1).

4. Reinstall the speaker cone-frame and the speaker housing.
5. Move the waist molding at the bottom of the window frame forward (see figure 2).
 - To move the waist molding, gently tap the end of the waist molding with a rubber mallet.
 - The front edge of the waist molding should be "flush" (even) with the front edge of the door.
